Failure monitoring in the cooling loop

Privatmolkerei Bauer, one of the leading producers of yoghurt and cheese in Germany, successfully uses Anderson-Negele ITM-4 turbidity sensors for failure monitoring in cooling loops.

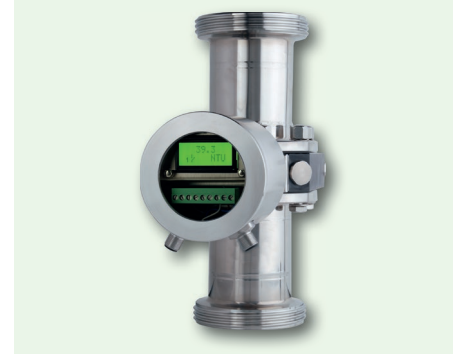
Turbidity meter ITM-4

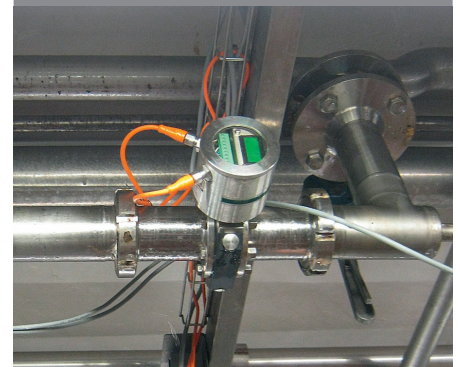
ITM-4 in return flow line

The solution lies in the application of ITM-4 turbidity sensors, which are used in the main cooling water supply line and in all return flow lines of the heat exchangers. The sensor measurements are displayed and recorded in a central control unit. The program compares the turbidity values measured in the return flow lines to the reference value of the supply line. A notification is issued in the control system if a turbidity value exceeds the alarm limit set in the program.

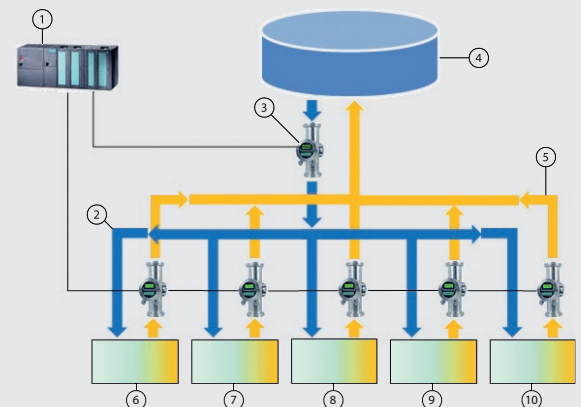
Schematische Prozessdarstellung

1. PLC
2. Main supply
3. Reference ITM-4
4. Cooling Water Tank
5. Recirculation
6. Load #1
7. Load #2
8. Load #3
9. Load #4
10. Load #5

Approx. 10 heat exchanger per load!

The cooling loop of the entire production plant consists of numerous heat exchangers in a widely branched piping system, all of which are supplied with ice water from two central ice water silos. Bauer was looking for a system to monitor the quality of the water in the cooling loop for the following reasons: First, the German Drinking Water Ordinance requires water that is used as process water or cooling water in the production of food or beverages to be of drinking water quality. Second, contamination ought to be excludable or at least instantly discernible. Leakages in the heat exchangers may lead to pollution of the cooling water or even to contamination of the product.
